New Hampshire Volunteer Lake Assessment Program

2003 Interim Report for Chalk Pond Newbury

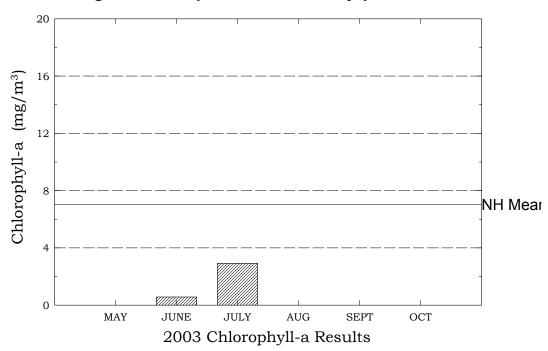
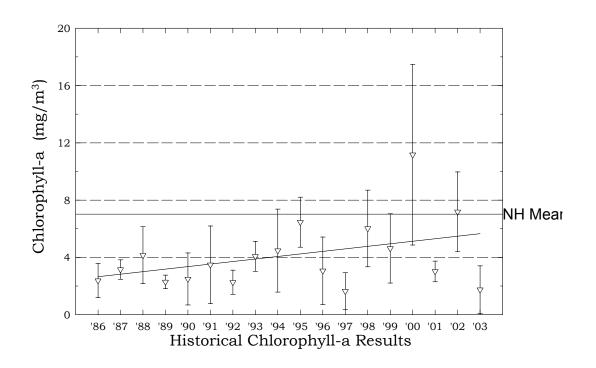
Figure 1. Monthly and Historical Chlorophyll-a Results

Figure 1 and Table 1: The graphs in Figure 1 (Appendix A) show the historical and current year chlorophyll-a concentration in the water column. Table 1 (Appendix B) lists the maximum, minimum, and mean concentration for each sampling season that the lake/pond has been monitored through the program.

The current year data (the top graph) show that the chlorophyll-a concentration *increased* from June to July. The chlorophyll-a concentration on both sampling events was *less than* the state mean.

The historical data (the bottom graph) show that the 2003 chlorophyll-a mean is **much less than** the state mean.

Overall, visual inspection of the historical data trend line (the bottom graph) shows *a variable*, *but overall increasing (meaning worsening)* in-lake chlorophyll-a trend since monitoring began in 1986. In the 2004 annual report, we will again conduct a statistical analysis of the historic data to objectively determine if there has been a significant change in the annual mean chlorophyll-a concentration since monitoring began.

While algae are naturally present in all lakes/ponds, an excessive or increasing amount of any type is not welcomed. In freshwater lakes/ponds, phosphorus is the nutrient that algae depend upon for growth. Algal concentrations may increase with an increase in nonpoint sources of phosphorus loading from the watershed, or inlake sources of phosphorus loading (such as phosphorus releases from the sediments). Therefore, it is extremely important for volunteer monitors to continually educate residents about how activities within the watershed can affect phosphorus loading and lake/pond quality.

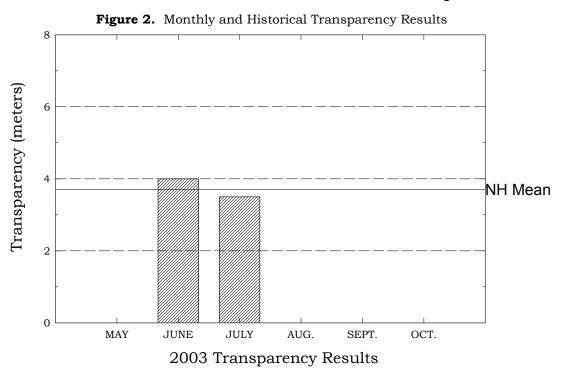
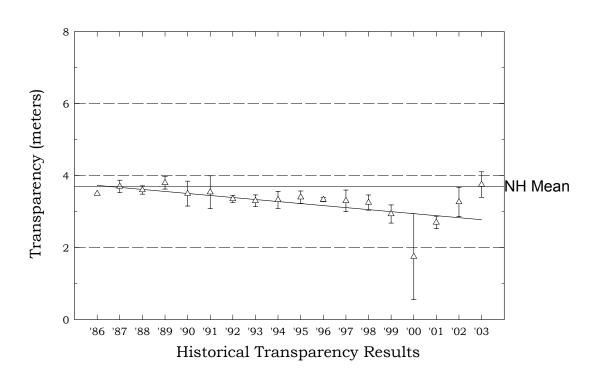
Figure 2 and Table 3: The graphs in Figure 2 (Appendix A) show historical and current year data for lake/pond transparency. Table 3 (Appendix B) lists the maximum, minimum and mean transparency data for each sampling season that the lake/pond has been monitored through the program.

The current year data (the top graph) show that the in-lake transparency **decreased** from June to July. The transparency in June was **slightly greater than** the state mean, while the transparency in July was **slightly less than** the state mean.

It is interesting to note that as the chlorophyll concentration increased from June to July, the transparency decreased. We generally expect this inverse relationship in lakes. As the concentration of algal cells in the water column increases, the ability for light to penetrate into the water column decreases.

The historical data (the bottom graph) show that the 2003 mean transparency is *approximately equal to* the state mean.

Overall, visual inspection of the historical data trend line (the bottom graph) shows *a variable*, *but overall slightly decreasing (meaning worsening)*, trend for in-lake transparency since monitoring began in 1986.

However, it is important to point out that the mean annual transparency has actually *increased (meaning improved)* from 2000

to 2003. This increase may be due to the recent diversion of roadway runoff within the watershed. We hope this trend continues.

Typically, high intensity rainfall causes erosion of sediments into lakes/ponds and streams, thus decreasing clarity. Efforts should continually be made to stabilize stream banks, lake/pond shorelines, disturbed soils within the watershed, and especially dirt roads located immediately adjacent to the edge of tributaries and the lake/pond. Guides to Best Management Practices designed to reduce, and possibly even eliminate, nonpoint source pollutants, such as sediment loading, are available from DES upon request.

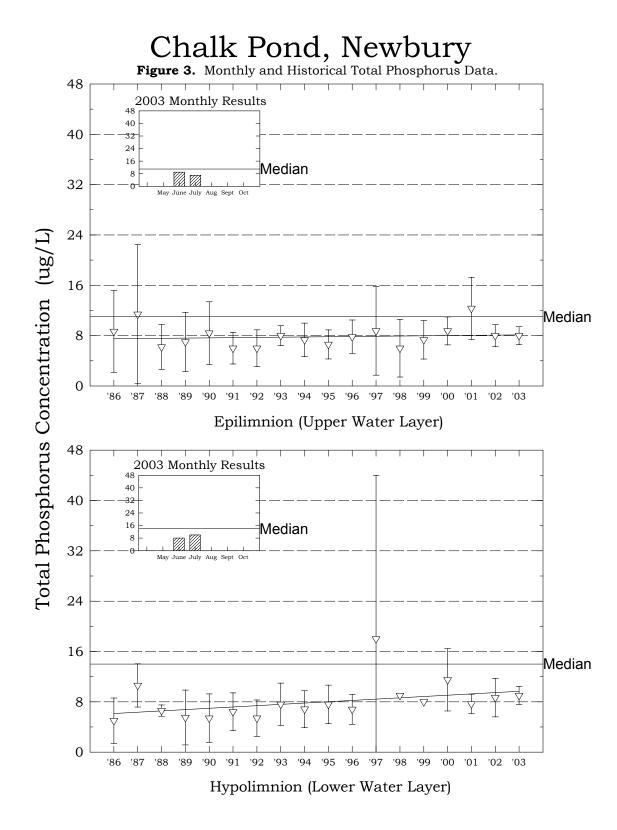
Figure 3 and Table 8: The graphs in Figure 3 (Appendix A) show the amounts of phosphorus in the epilimnion (the upper layer) and the hypolimnion (the lower layer); the inset graphs show current year data. Table 8 (Appendix B) lists the annual maximum, minimum, and median concentration for each deep spot layer and each tributary since the lake/pond has joined the program.

The current year data for the epilimnion (the top inset graph) show that the phosphorus concentration **decreased slightly** from June to July. The phosphorus concentration on both sampling events was **less than** the state median.

The current year data for the hypolimnion (the bottom inset graph) show that the phosphorus concentration *increased slightly* from June to July. The phosphorus concentration on both sampling event was *less than* the state median.

Overall, visual inspection of the historical data trend line for the epilimnion shows **a relatively stable** phosphorus trend, which means that the concentration has **remained approximately the same** since monitoring began.

Overall, visual inspection of the historical data trend line for the hypolimnion shows **a slightly increasing** phosphorus trend, which means that the concentration has **slightly worsened** since monitoring began.

One of the most important approaches to reducing phosphorus loading to a waterbody is to continually educate watershed residents about its sources and how excessive amounts can adversely impact the ecology and value of lakes and ponds. Phosphorus sources within a lake or pond's watershed typically include septic systems, animal waste, lawn fertilizer, road and construction erosion, and natural wetlands.
